Manhole Inspection Summary

Manhole # S15AA1009MH

Insp Date: **3/22/07 12:29 PM**

Location Address: **3619 COTTAGE AVE**

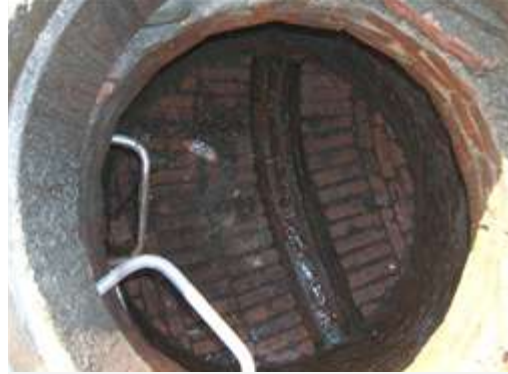
Top View

Evidence of surcharge - Bench debris.
Corroded steps.

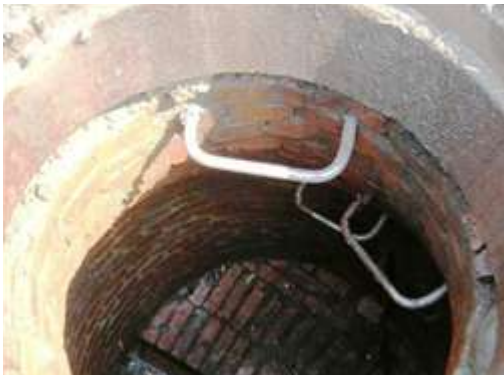
Defect

Frame leaks. Frame offset. Adjustment
deterioration, loose brick and infiltration.
Corbel and Barrel infiltration- other side.

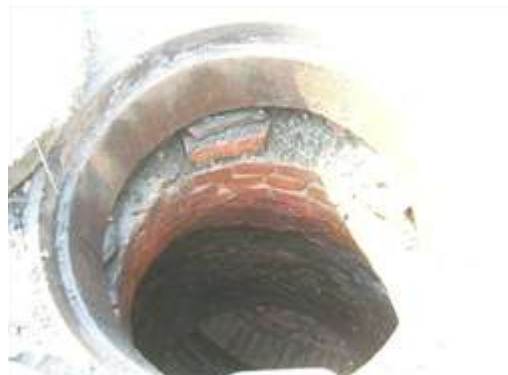
Defect

Frame leaks. Frame offset. Adjustment
deterioration, loose brick and infiltration.
Corbel and Barrel infiltration.

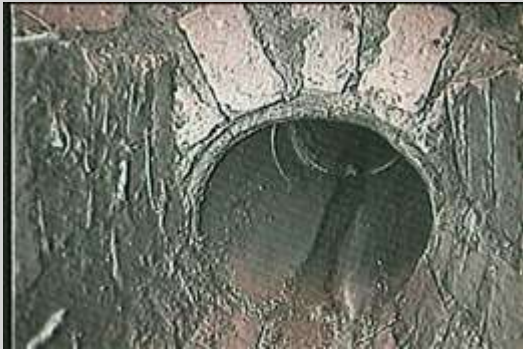
8 in. Circular Gravity Sewer Pipe Out @ 12 O'Clock

Infiltration: **Evidence** Pipe Seal Cond: **Unknown**

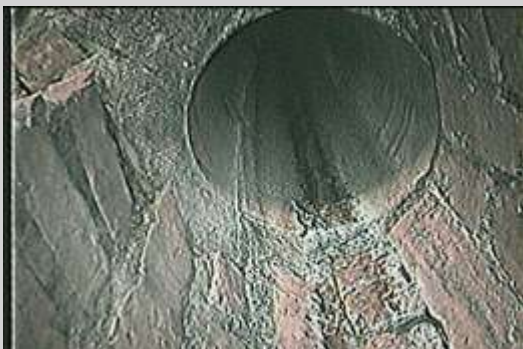
8 in. Circular Gravity Sewer Pipe In @ 5 O'Clock

Deposits: ☐ None ☐ Mud ☐ Sludge ☐ Debris ☒ Grease

Silt Depth: **0** (in.) Deposits Extent: **Light**
